Sustainable Re-use of Tyres in Port, Coastal and River Engineering

Guidance for planning, implementation and maintenance

**Report SR 669
Release 1.0
March 2005**

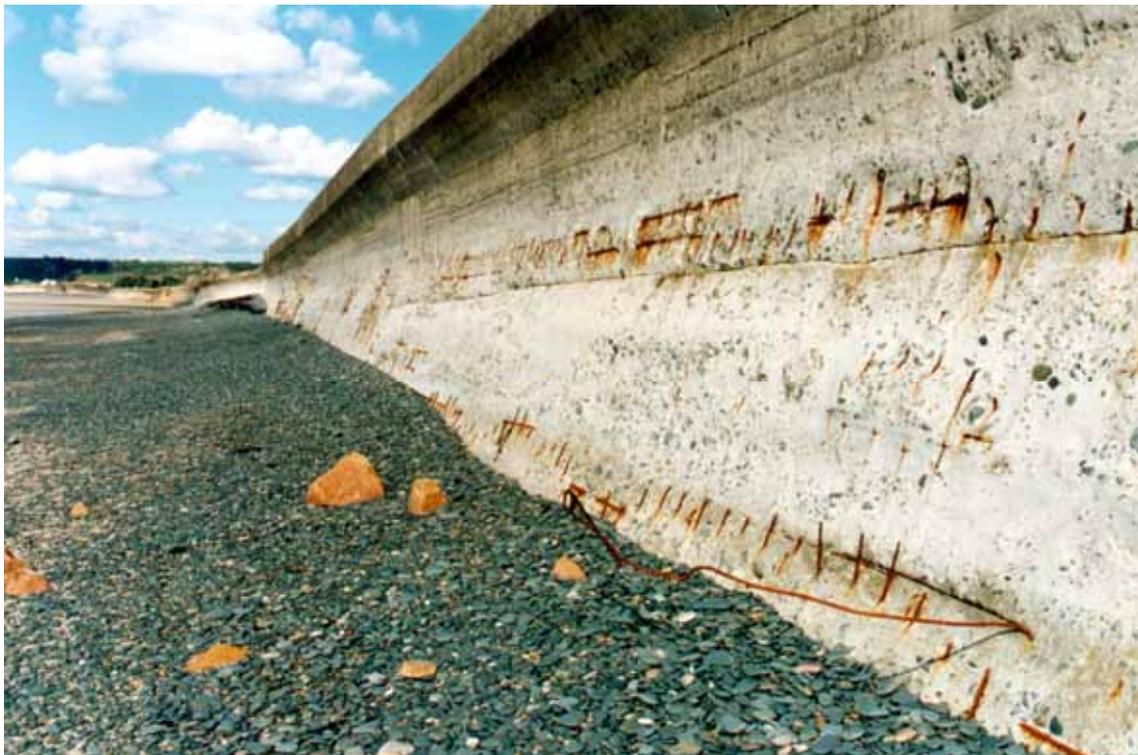
Figure 3.2 An example of hydrodynamic abrasion exposing steel reinforcement in a concrete seawall

There are limitations however to the use of tyre materials, specifically for Portland Cement in concrete applications. The durability of coastal structures, such as concrete seawalls, and their ability to resist abrasion and chemical attack is very important. Any structure on a sand or shingle foreshore will be subject to some degree of abrasion as a result of the impact of particles driven by hydrodynamic forces. This abrasion (for example see Figure 3.2) can significantly affect the residual life span of a concrete structure. Abrasion rates in excess of 6mm/yr have been experienced at sites where concrete structures are located in very aggressive environments.

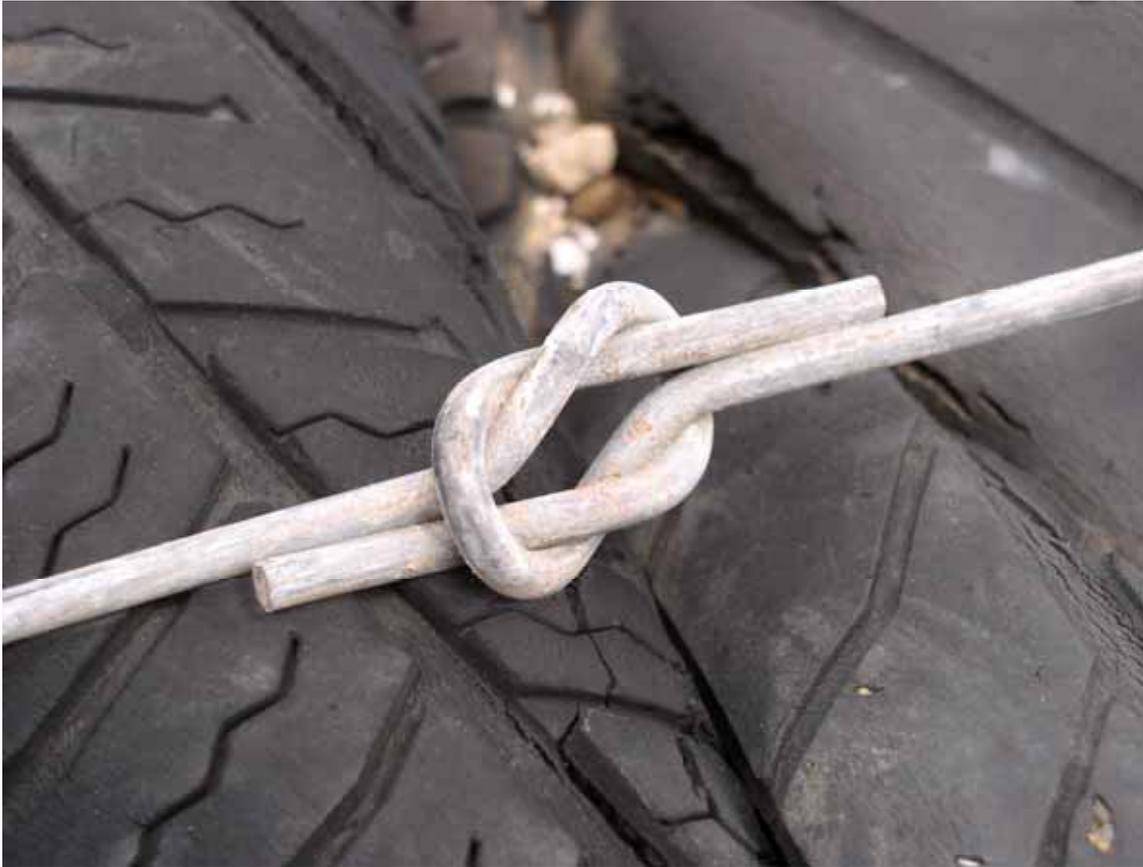
Figure 4.3 Galvanised steel wire fastening

The size of the bale is determined by the chamber size of the baler and the length of the wrapping wires or straps. Firstly about 100 or so tyres (car/van or ~ 90 truck) are placed into the bale chamber in a weave pattern. Next the hydraulic compactor compresses the tyres for 10 to 20 seconds with around 65 tonnes of pressure into a rectangular block measuring roughly 75cm x 150cm x 135cm and weighing about 1 tonne. This block is then 'baled', bound up with five, 4 metre long bands of 4mm thick high tensile, high carbon, electro-galvanised or stainless steel wires. These wires have a tensile strength of 1500 to 170N/mm². Revetment cord is also sometimes used.

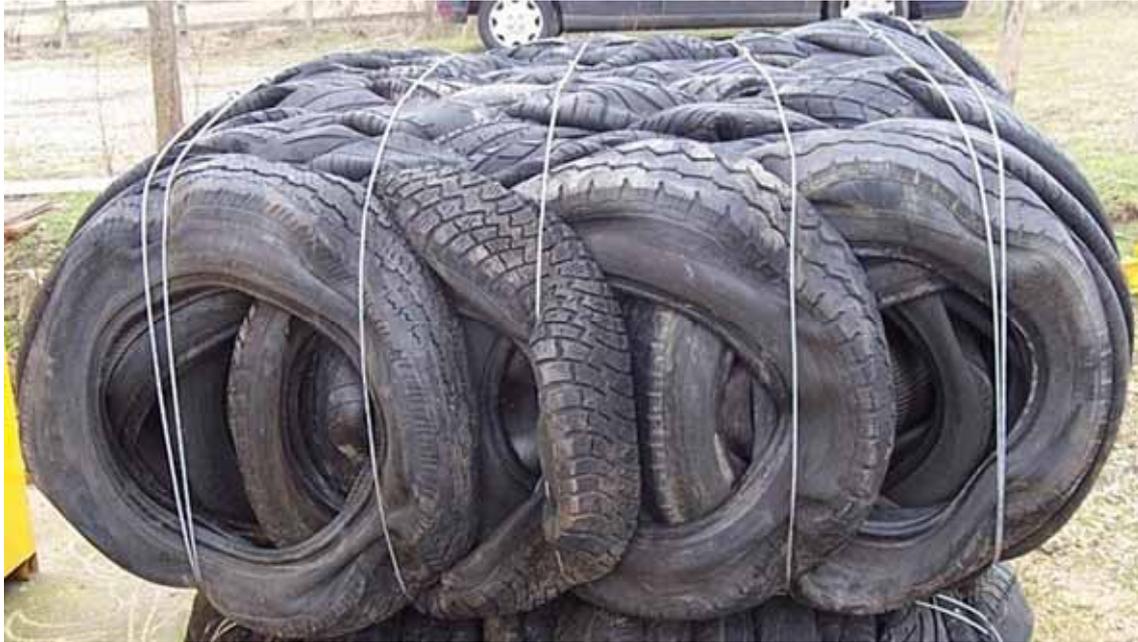
Figure 4.4 Baled product containing approximately 100 used tyres (courtesy Environment Agency)

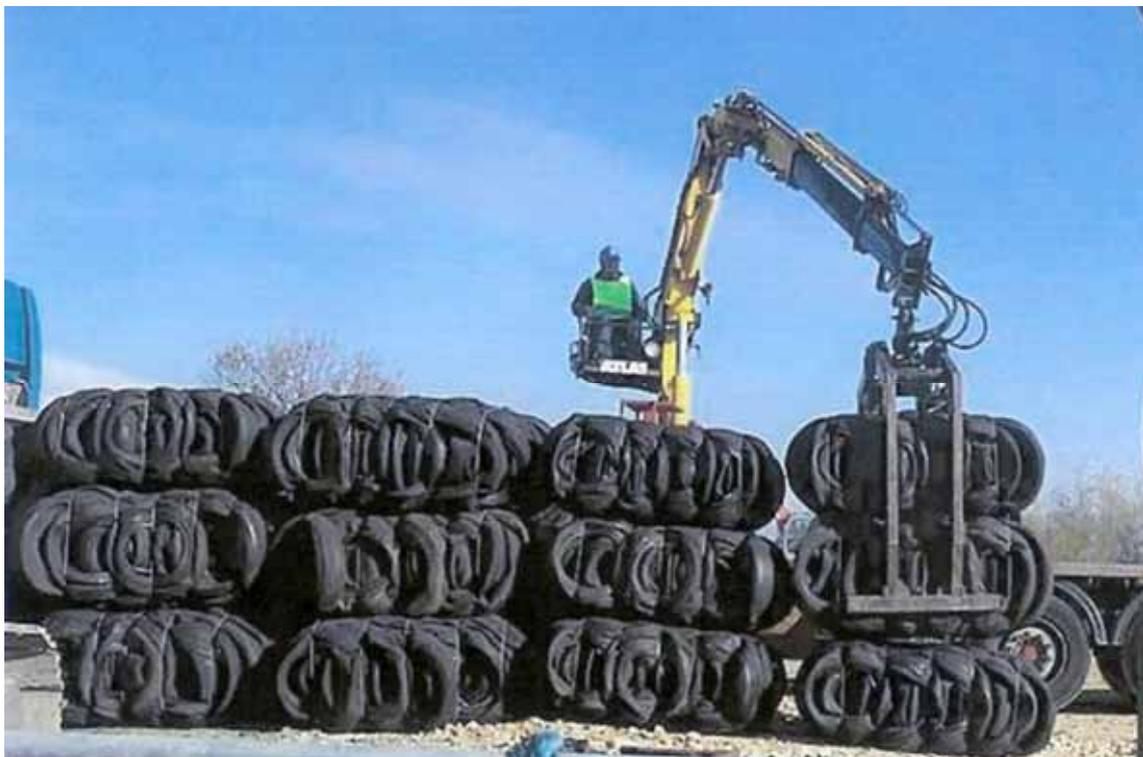
Figure 4.5 Offloading tyre bales from a delivery vehicle at a project site. (courtesy Environment Agency)

Loading and offloading tyre bales from flat-bed lorry trailer units are easily and safely facilitated with the use of a mounted crane and pallet grab (See Figure 4.5). Placement of the bale into a structure is best achieved with a similar attachment as shown in Figure 4.7. The hydraulic functions of the gib and head-stock allow precision and accuracy of movement for optimal control including 360° plane rotation of the bale for choice placement.

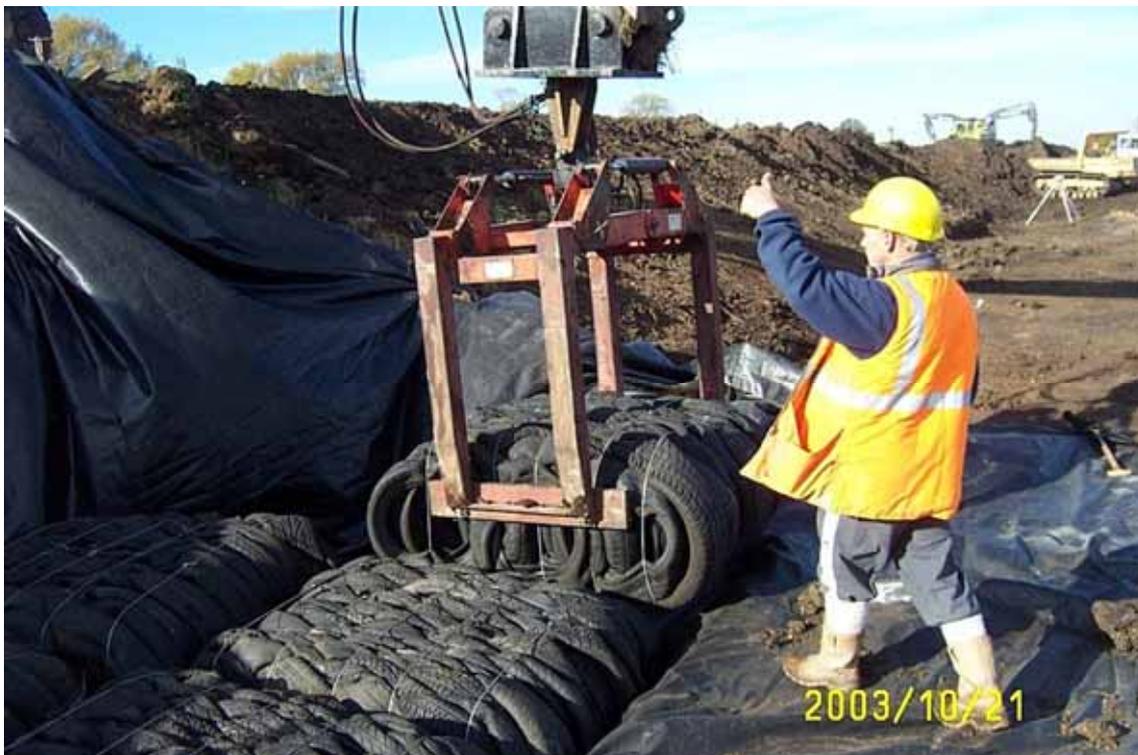
Figure 4.7 Placement of tyre bale into structure using a pallet grab attachment (courtesy Environment Agency)

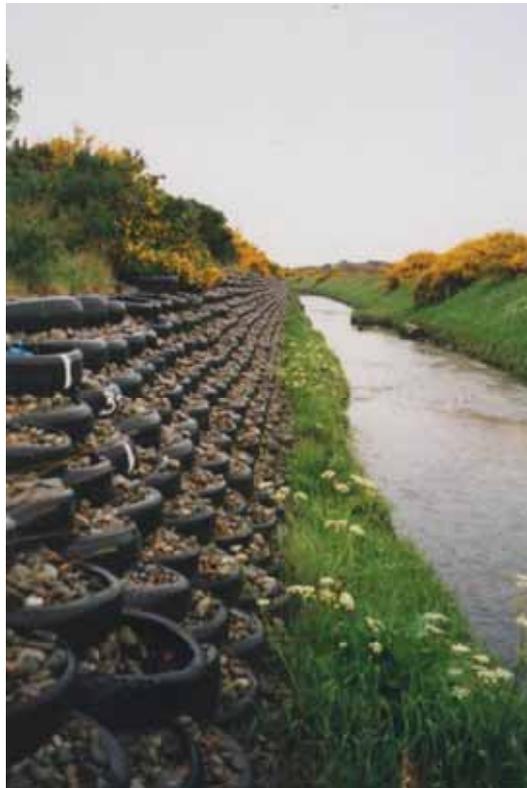
Figure 5.2 The tyre revetment beside the Mill Burn (courtesy Environment Agency)

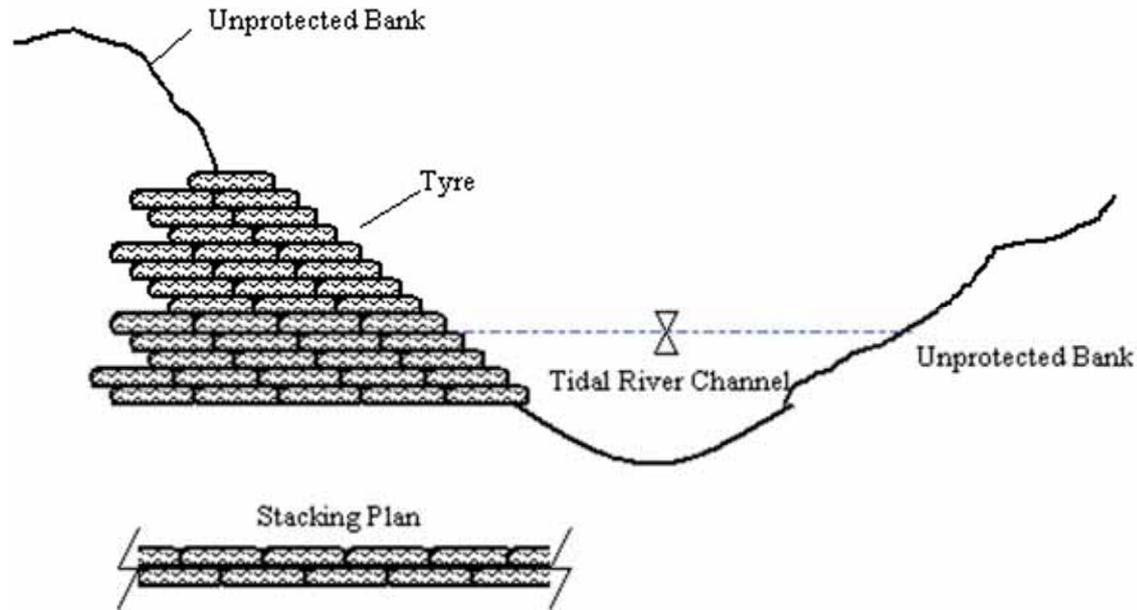
Figure 5.3 Schematic of the tyre revetment/retaining wall on the Mill Burn

To accommodate the landfill site here the Mill Burn route itself had to be engineered in order to prevent erosion of the adjacent landfill area by the river.

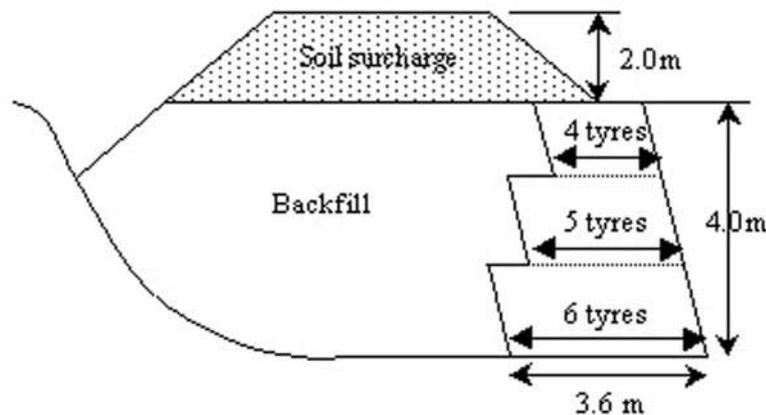
Figure 5.5 Configuration of the soil-tyre gravity test wall

Following the trial several slope stabilisation projects in Brazil built tyre-soil gravity retaining walls.

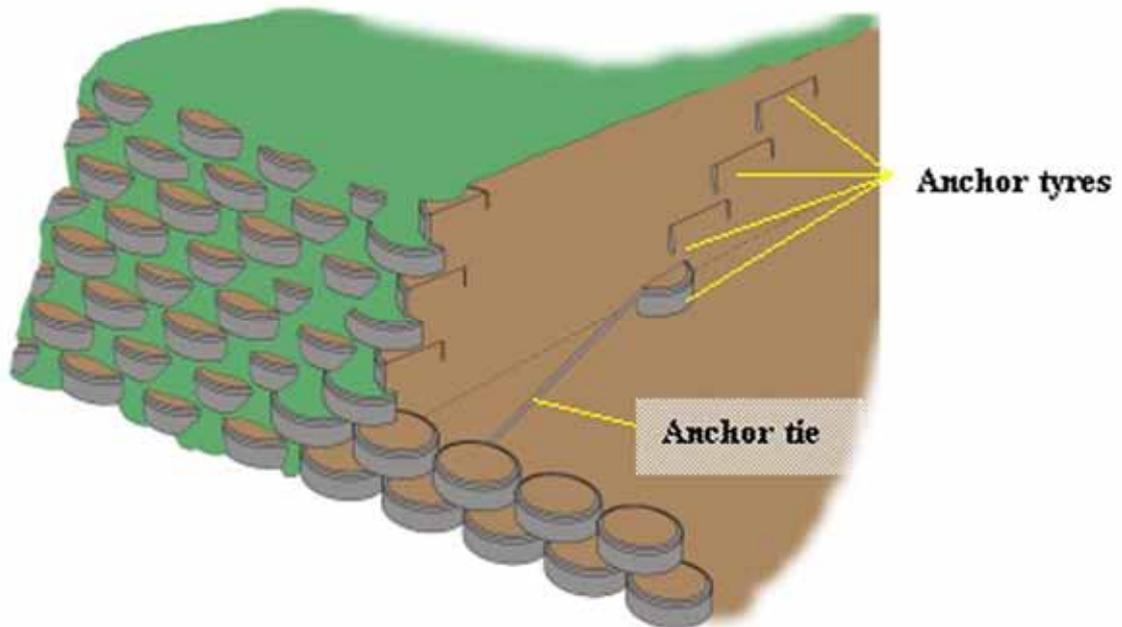
Figure 5.6 Gravity retaining wall structure showing anchor ties and tyres

Truck/lorry tyres can also be used in this way. Removal of the sidewall from truck tyres is not so important as these tyres are heavier and access for filling the tyres with 'ballast' is easier due to their larger size. Linkage of the tyres however is still recommended as lateral deformation or loss of individual units may still occur, especially if subject to wave or tidal forces as described in the Copperas Wood example in Box 5.1.4.

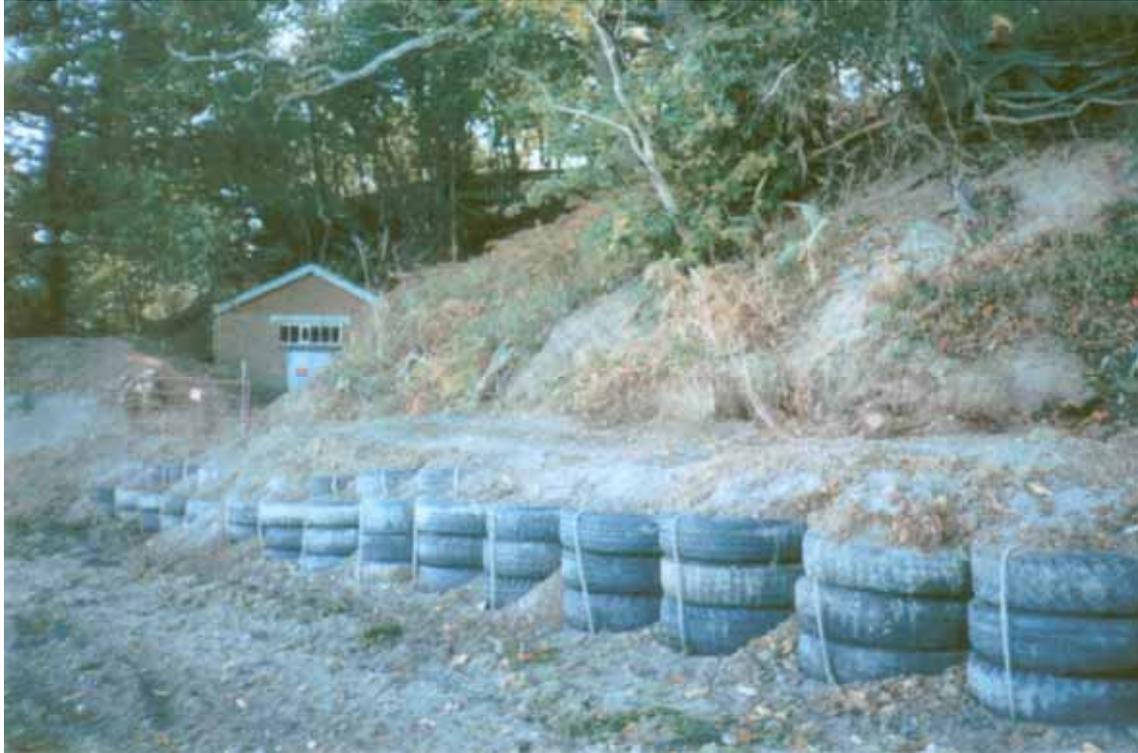
Figure 5.7 The Copperas Wood defence soon after construction (courtesy of Sorrell Flood Protection)

Whole tyre mats (two tyres deep) stacked 4 high into rafts were used to protect 150m of foreshore in Copperas Bay in the Stour Estuary (Suffolk /Essex boundary, UK) (see Figure 5.7). The Stour estuary has exhibited some of the highest rates of historical salt marsh loss in the UK. Copperas Bay has experienced near total saltmarsh loss, and ancient oak and coppiced woodland begun to be lost as the toe of the low cliff was destabilised by wave action.

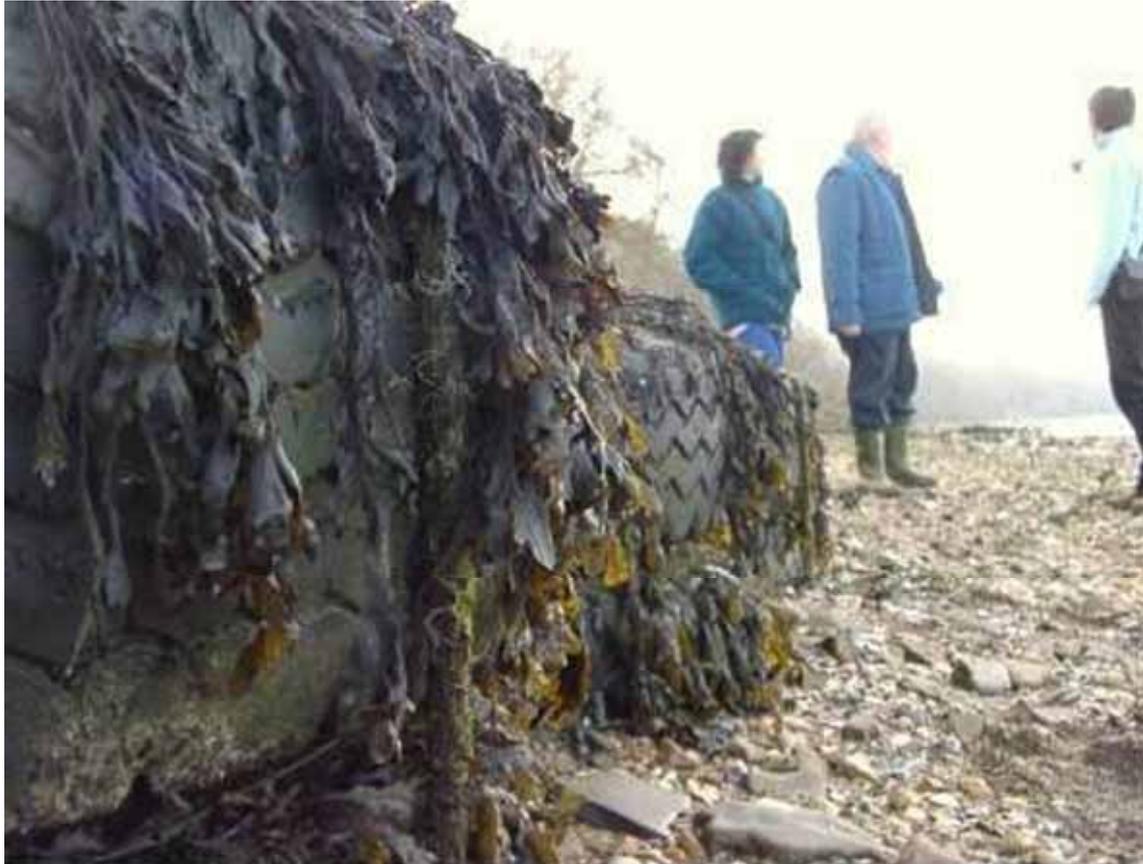
Figure 5.9 Algal growth on the Copperas Wood tyre embankment (courtesy Dr Ken Collins)

Partly buried within a shallow trench cut into the upper foreshore along the cliff base keeps the tyres stable under all the tidal conditions experienced with no evidence of floating up during high water levels (Watson and French, 1999). Post installation monitoring has shown the system to be extremely stable and with no discernible displacement observed during the first 18 months. Shortly after installation when a high tide overtopped the defence, some removal of soil from the voids between the tyres and from on top of the structure was observed. However since then no subsequent problems of this nature have occurred (See Figure 5.8) and seaweed has successfully colonised areas of the structure reached by the tide (see Figure 5.9).

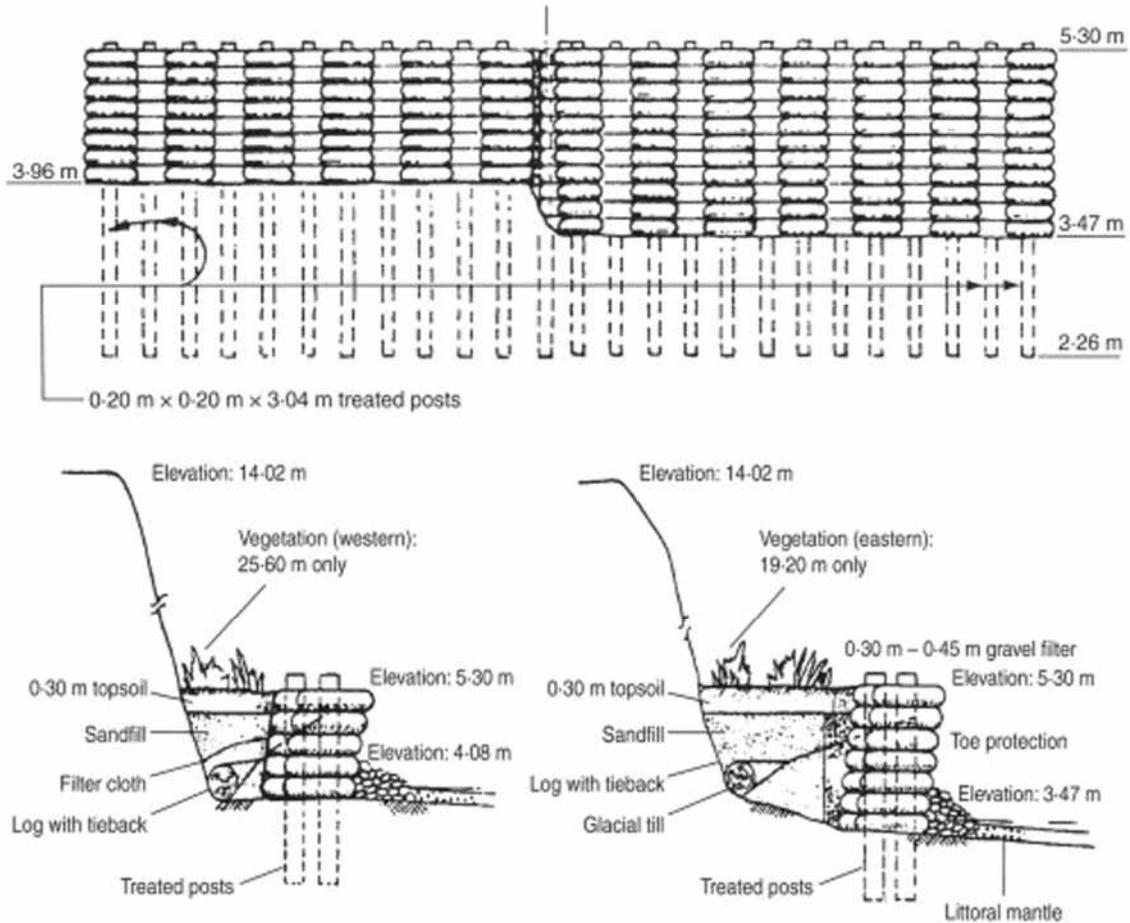
Figure 5.10 Schematics of the tyre and post revetment at Oak Harbour, Washington, USA (Motyka and Welsby, 1983)

The tyre and post revetment in Oak Harbour, Washington, in the USA consisted of two lines of vertical posts driven into the beach (see Figure 5.10). Car tyres were laid over the posts, filled with gravel and a filter cloth placed between the tyres and the backfill. The structure performed successfully but the gravel fill was lost from inside the tyres and there was some erosion of backfill.

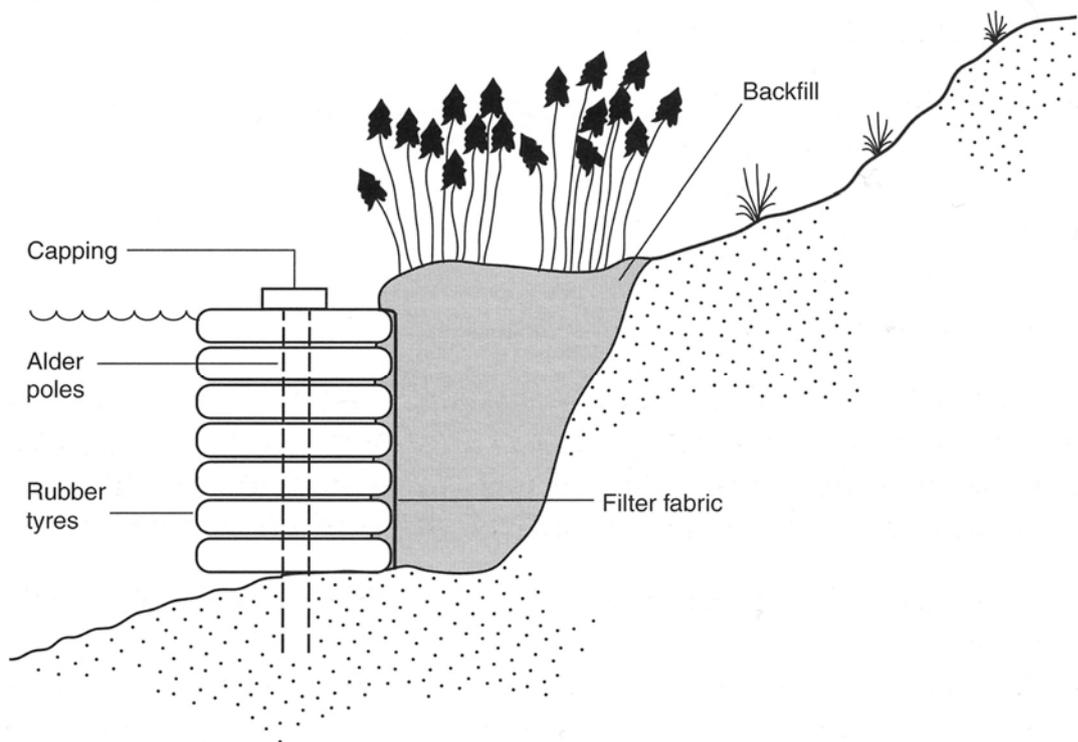
Figure 5.11 Schematic of the vertical tyre defence on the River Bure, Norfolk, UK

The Environment Agency used rubber tyres in bank protection along the River Bure near South Walsham in Norfolk. Constructed in 1987 on the outside of a meander, it was designed to protect the riverside footpath from undercutting by erosion. This was carried out as part of a trial along with other methods of bank protection and proved to be successful. However, it did prove difficult to install the tyres underwater as horizontal connections could not be obtained and backfill material was lost owing to the movement of the tyres under wave attack. Although tidal at this point on the Bure only the top two or three tyres in each stack are subjected to wetting and drying. Latterly it has been observed that the tyres had partially filled with silt and had good reed growth on the backfill.

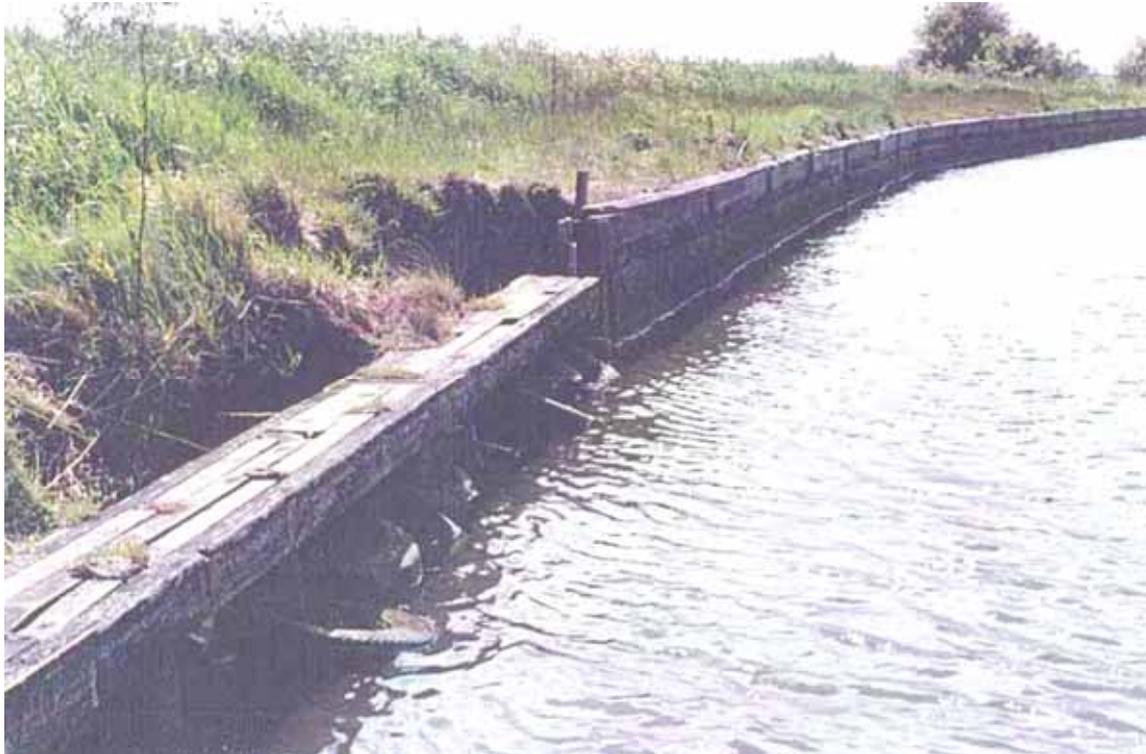
Figure 5.12 Tyre and post bank protection (courtesy Environment Agency)

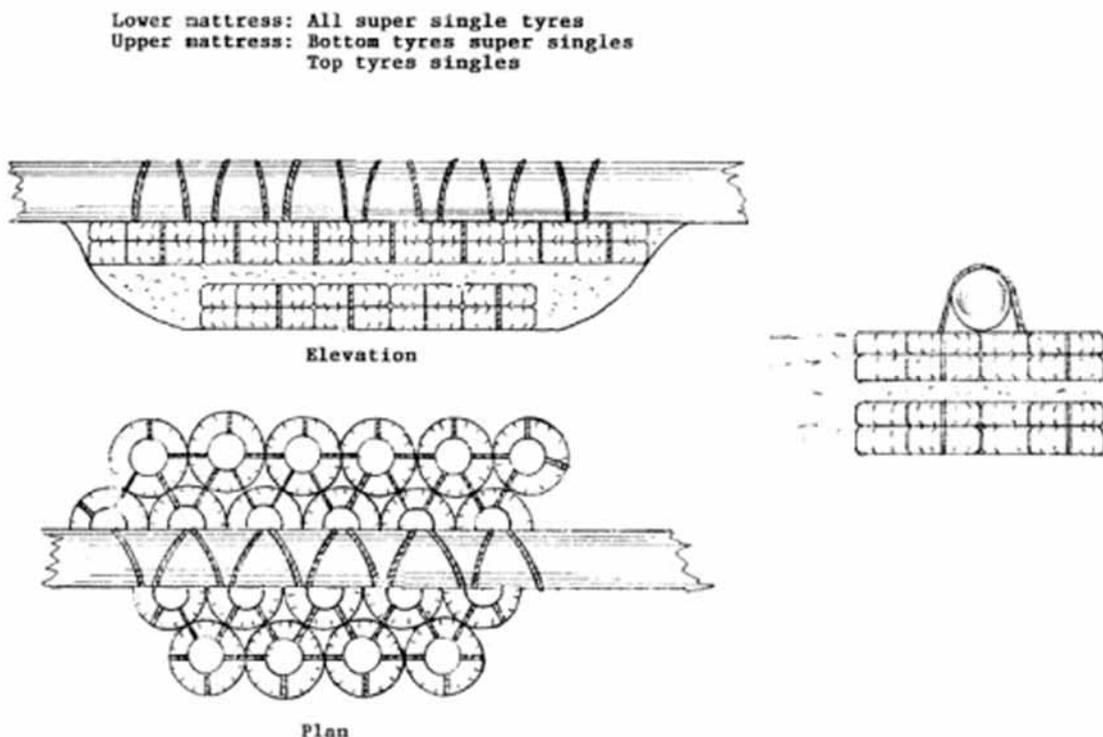
Figure 5.13 Schematic design of the ‘Sorrell’ anti-scour mattress

This system is much cheaper than alternative methods and the tyres are able to fill a large scour hole more easily than gravel, bags of concrete or other materials. Each tyre takes up a comparatively large volume and can be lowered into place bound in large groups reducing installation time and costs. The hollow nature of the tyres allows easy anchorage to the pipeline and in addition exhibit low buoyancy as they become filled with sand (Garnsey and Leacock, 1998).

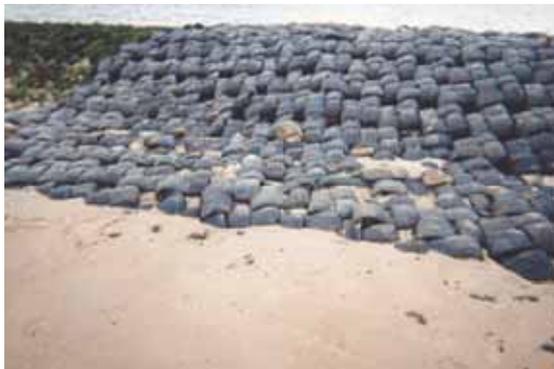
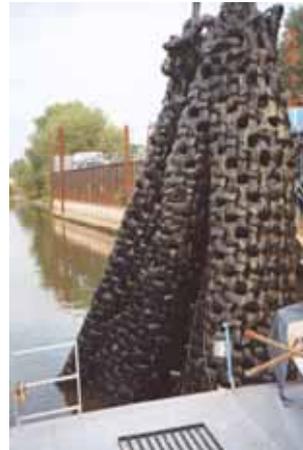
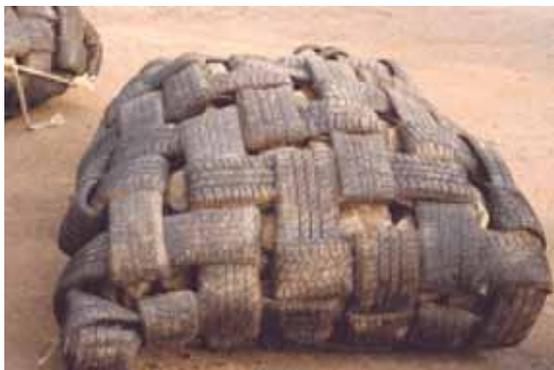
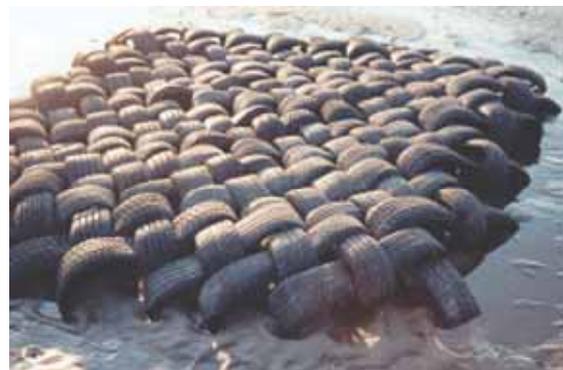
Figure 5.14 RINGtech® erosion protection matting and hollow bodies (courtesy RINGtech®)

These systems have only been tested so far in marine applications. An assessment by the Federal Institute for Hydro-construction confirmed the anti-erosion properties of the RINGtech® products, especially in marine construction. This recommendation refers specifically to erosion protection for marine structures, e.g. bed or scarp protection and the construction of groynes and reefs. After successful tests with propeller induced currents during ship-berthing manoeuvres as well as a number of flexibility tests, carried out in March and in October 2000, the Federal Institute for hydro-construction certified RINGtech® mats specifically as a suitable bottom protection system.

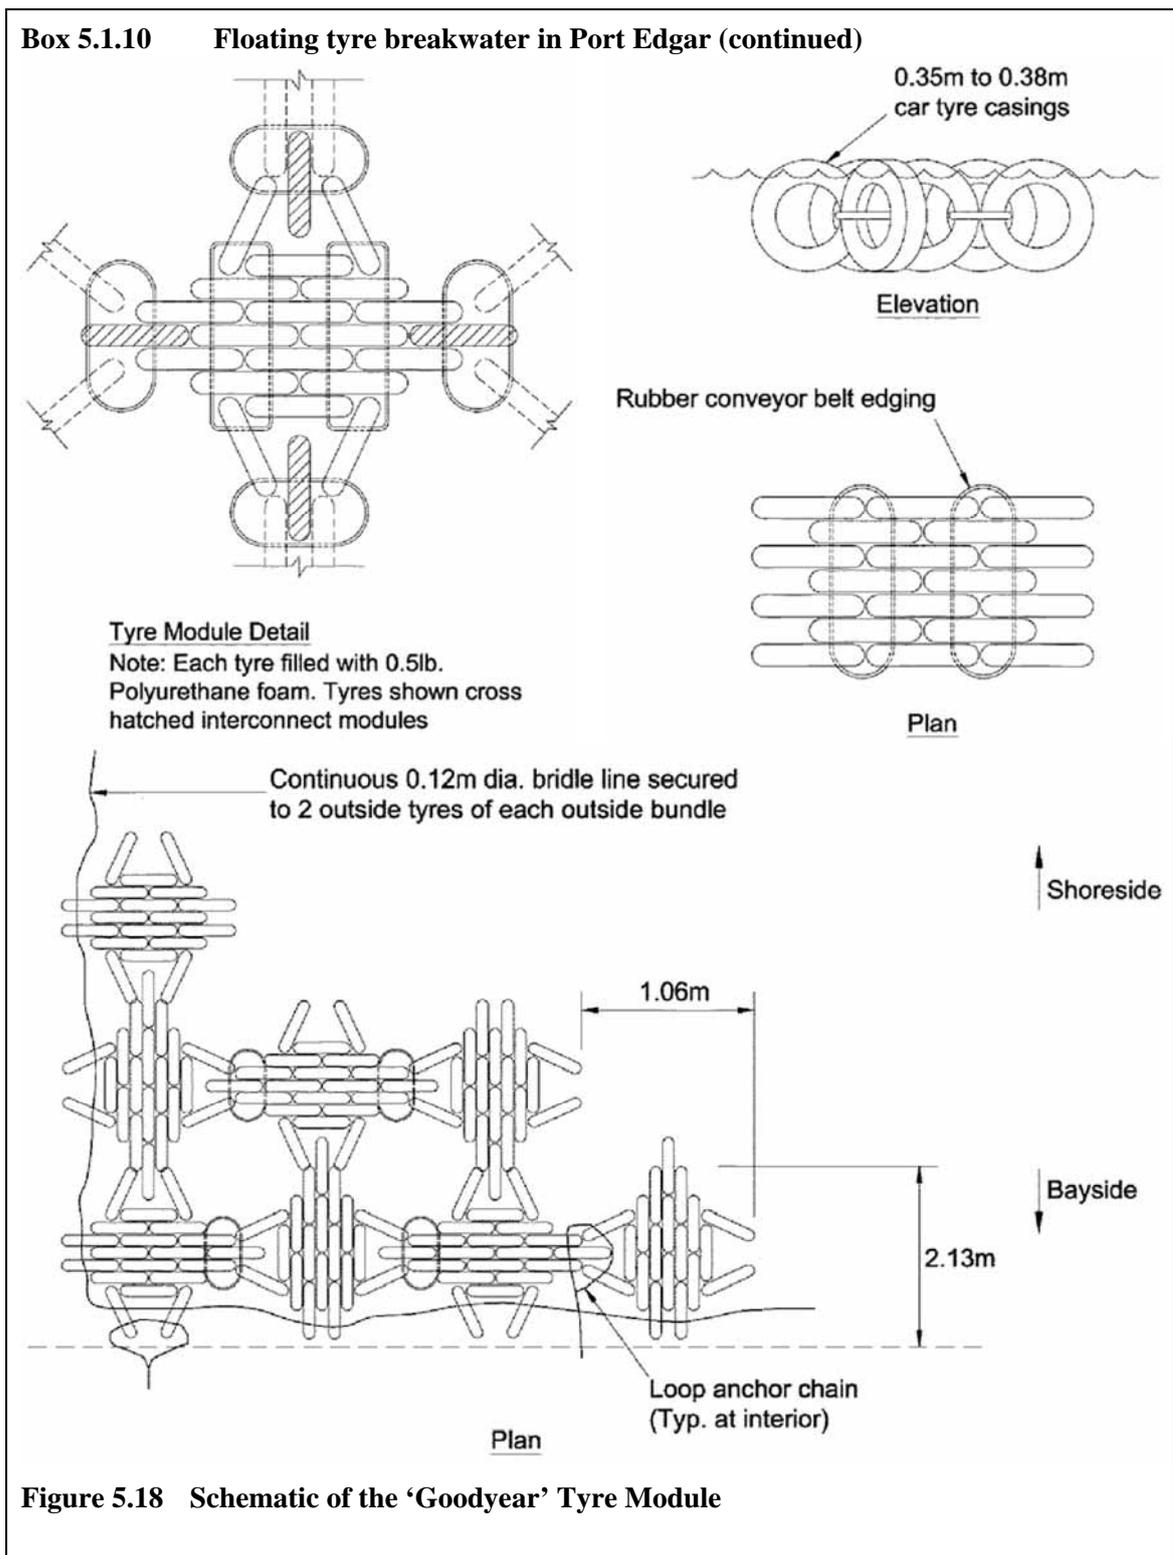
The system used for the Port Edgar breakwater is known as the 'Goodyear module'. Figure 5.18 shows the configuration and fastening of the design.

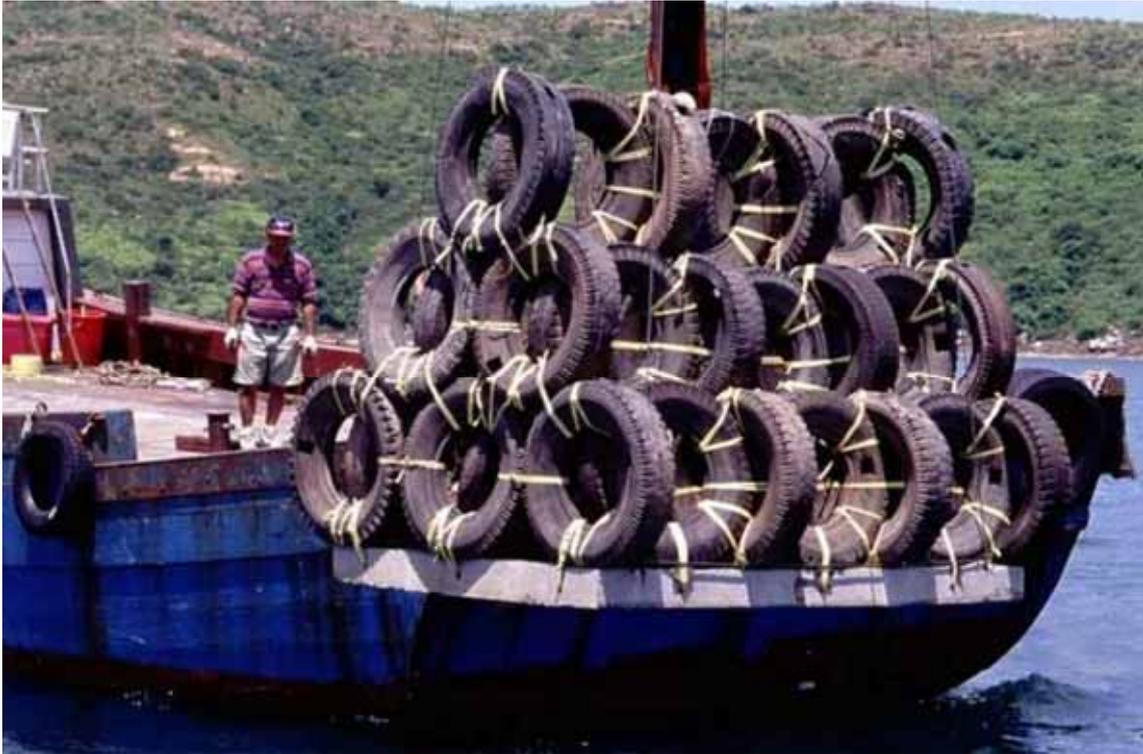
Figure 5.20a Open lattice reef structure (using either just 4, or 13 or more tyres held together by stainless steel bolts and with the basal tyres filled with concrete)

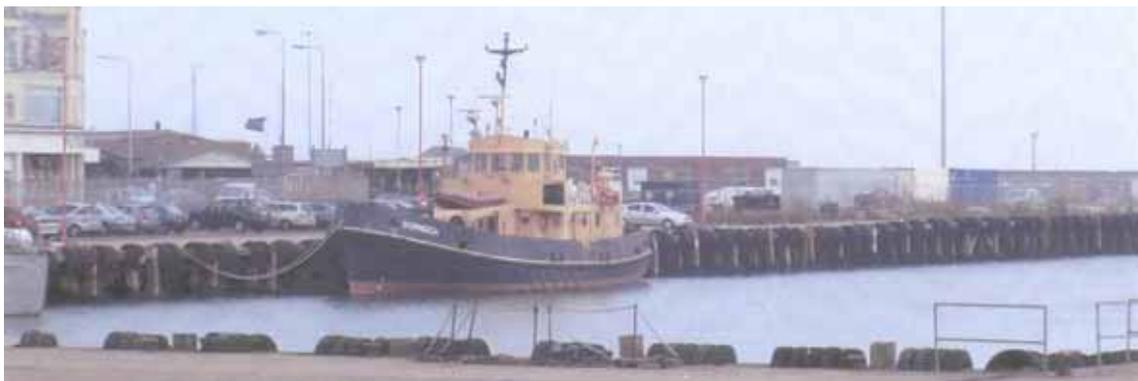
Figure 5.22 Tyres used as mooring fenders on Lowestoft wharf s (courtesy Sorrell Flood Protection)

Usually tyres are slung singly by ropes or chains over the gunwhale or quayside to absorb mooring energies and prevent damage to vessel and quay alike.

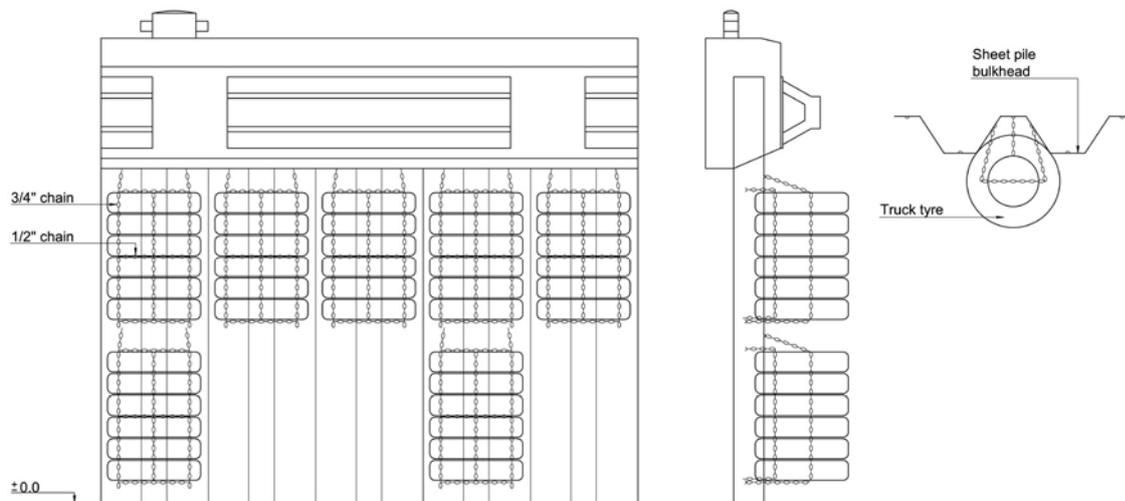
Figure 5.24 RTT ship fender system 1

The Reykjavik design found that by covering the whole quay with RTT fenders, two rows in height, spaced at 1.6m o.c., the RTT fenders can provide adequate energy absorption for berthing impact loads for ships up to 17,500 DWT (assuming the mean deflection of the fenders engaged is 25%).

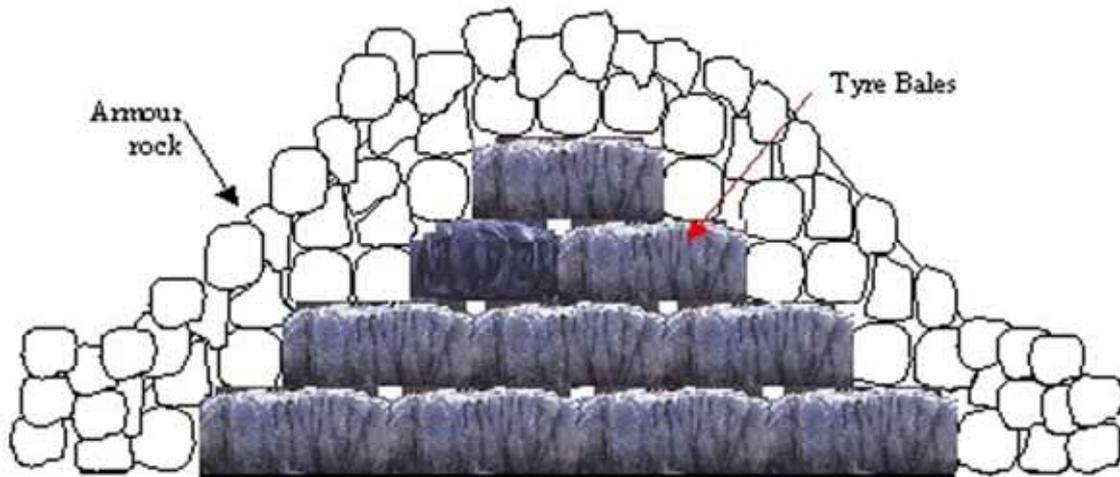
Figure 5.28 Suggested test tyre bale configuration as hearting for rock groynes

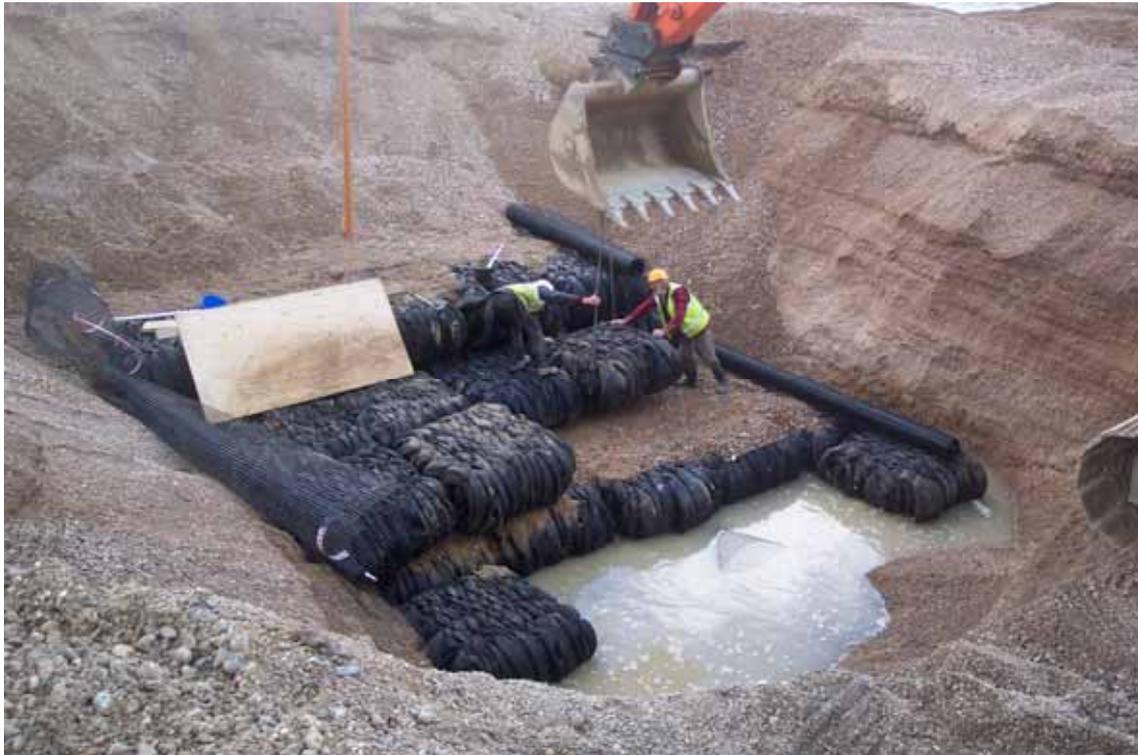
Figure 5.29 Installation of bales in the beach at Pevensey Bay in East Sussex (courtesy PCDL)

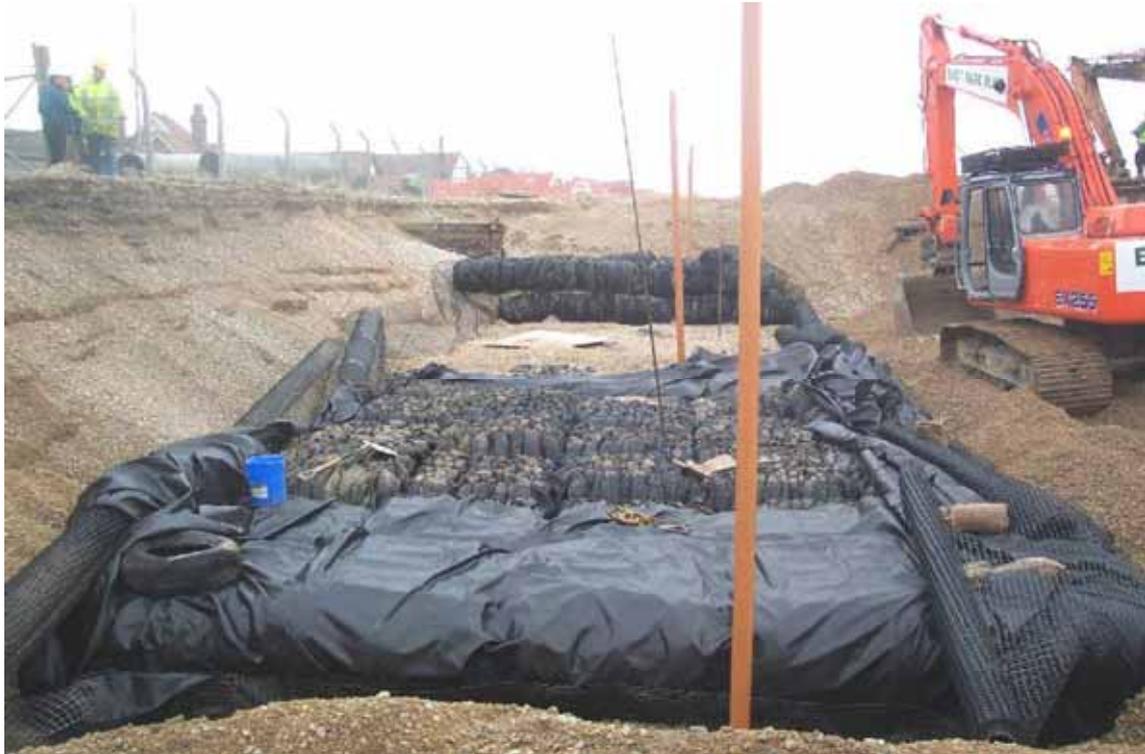
Figure 5.30 Pevensey Bay project near completion with sampling pipes in situ. (courtesy PCDL)

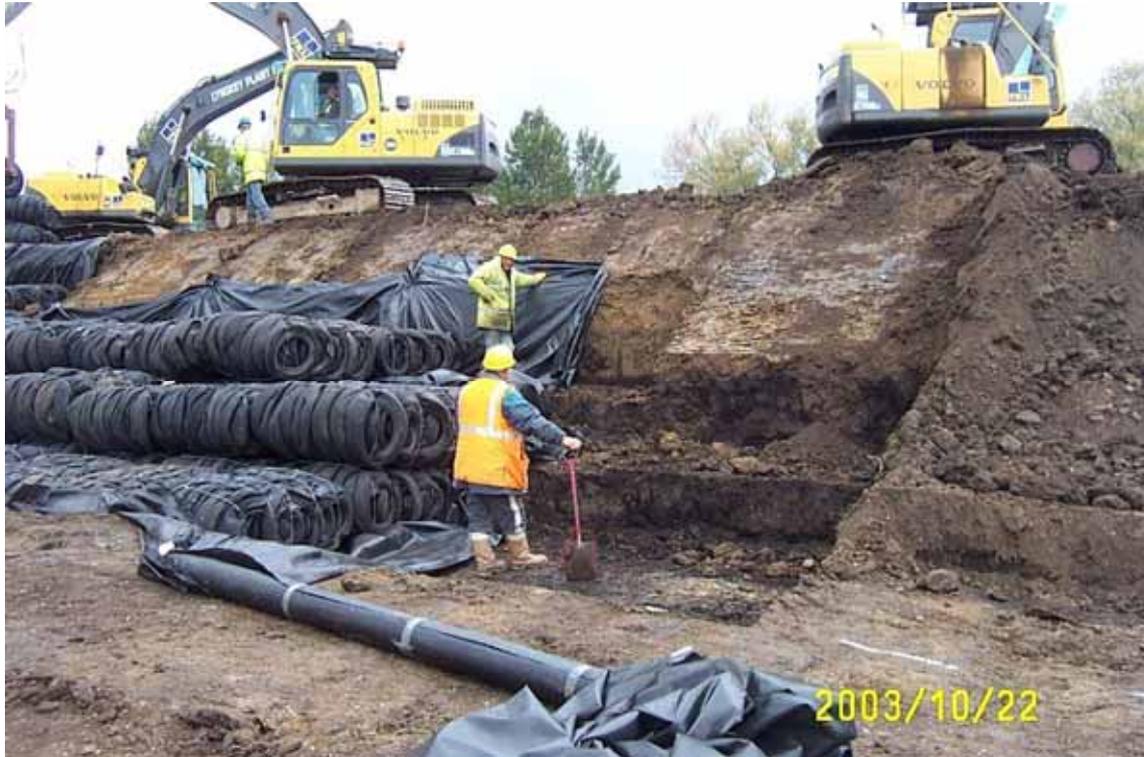
Figure 5.31 Design and works for the River Witham Flood Embankment (courtesy Environment Agency)

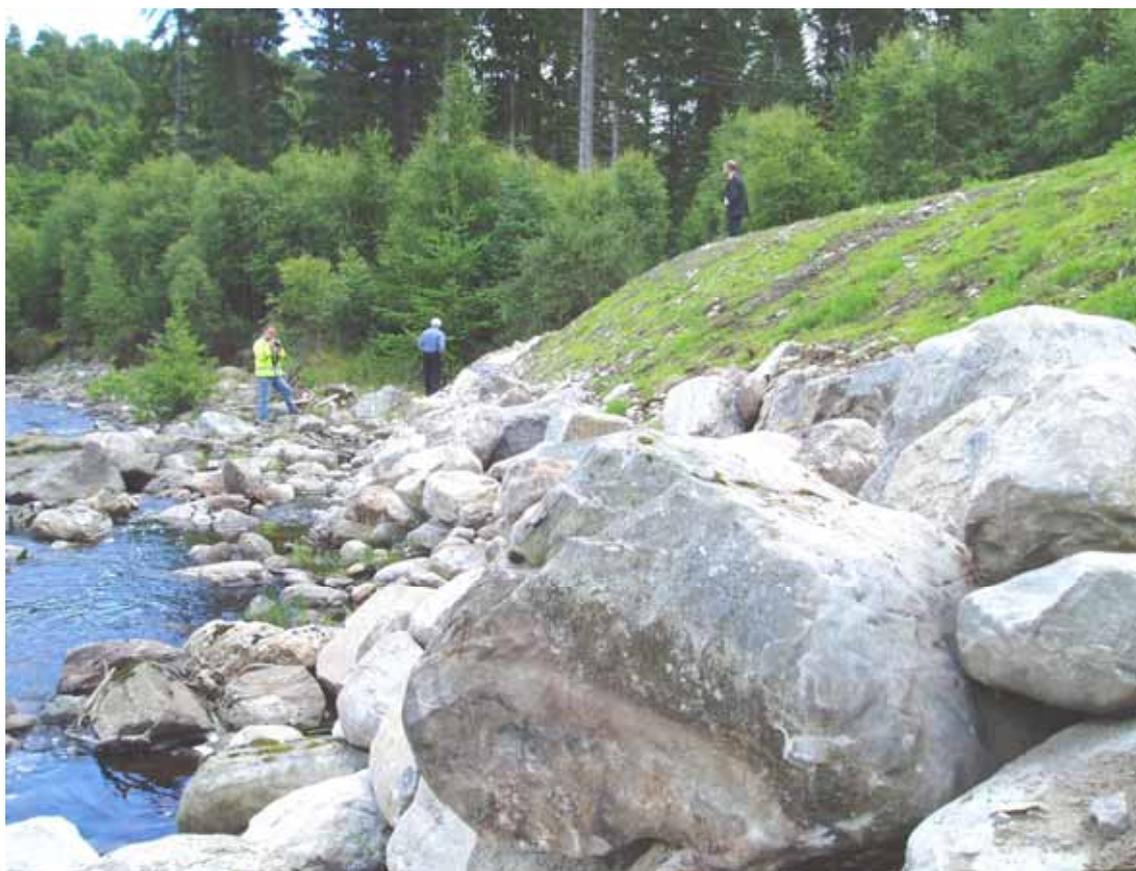
Figure 5.35 Rock armour placed for bank toe protection
