Sustainable Re-use of Tyres in Port, Coastal and River Engineering

Guidance for planning, implementation and maintenance

**Report SR 669
Release 1.0
March 2005**

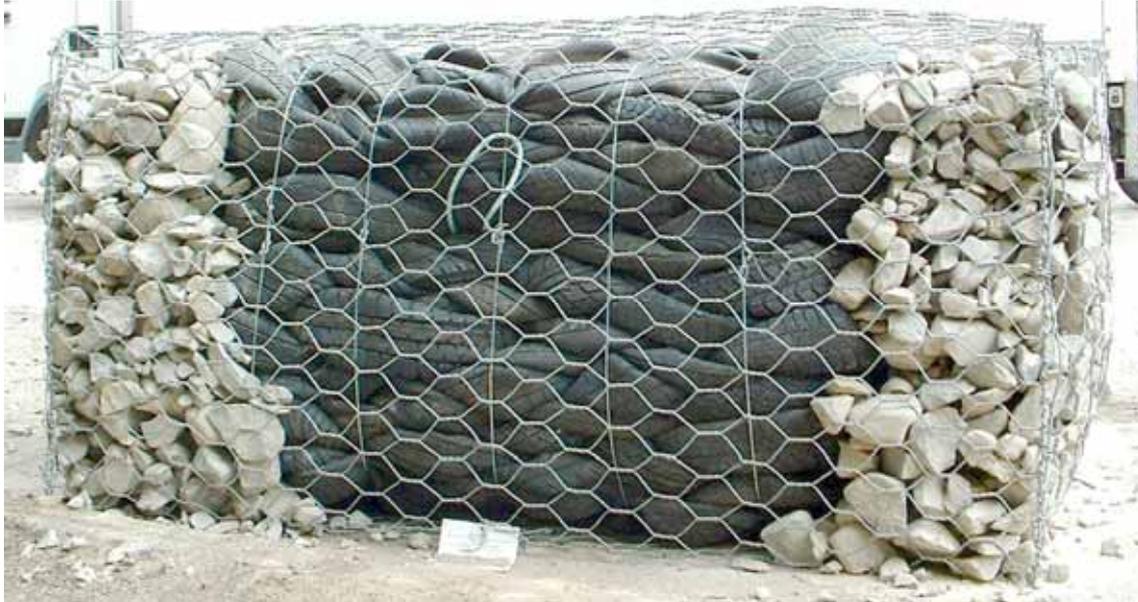
Figure 5.38 Tyre bale as centre fill for gabion box (courtesy Northern Tyre Recycling)

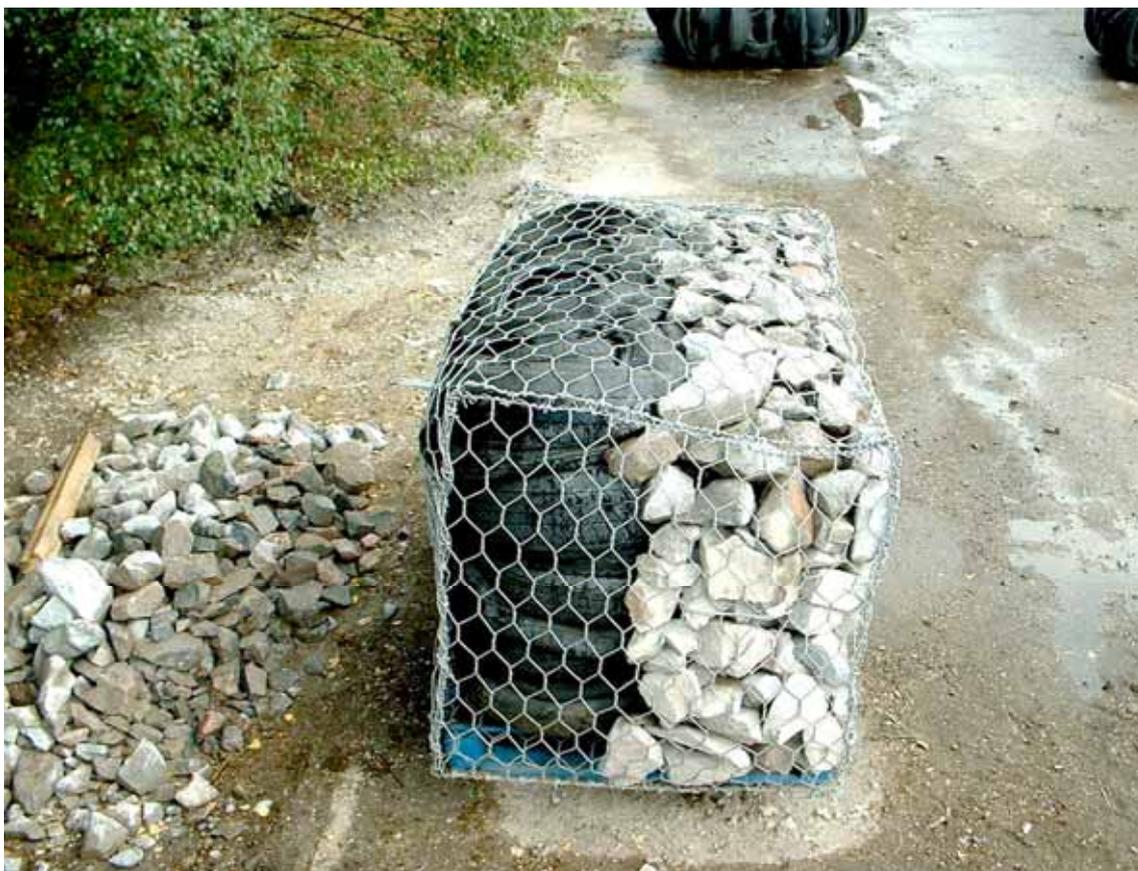
Figure 5.39 Tyre bale as rear fill for gabion box (courtesy Northern Tyre Recycling)

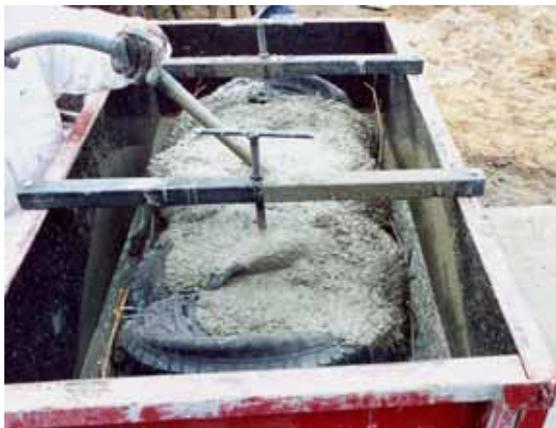
Figure 5.40 Concrete being poured around tyre bale into block cast (courtesy Northern Tyre recycling)

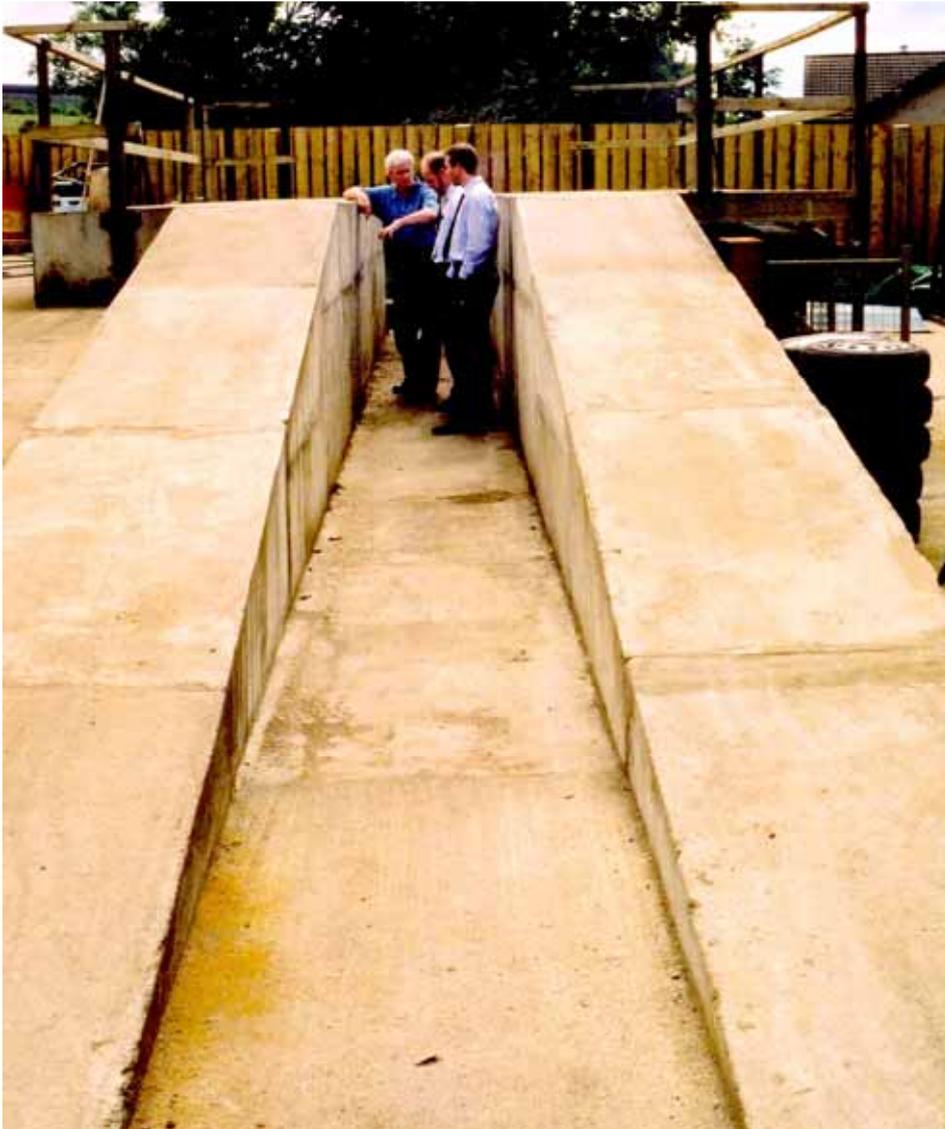
Figure 5.42 Car ramp constructed of tyre bale/concrete blocks (courtesy of TRL Ltd ©)

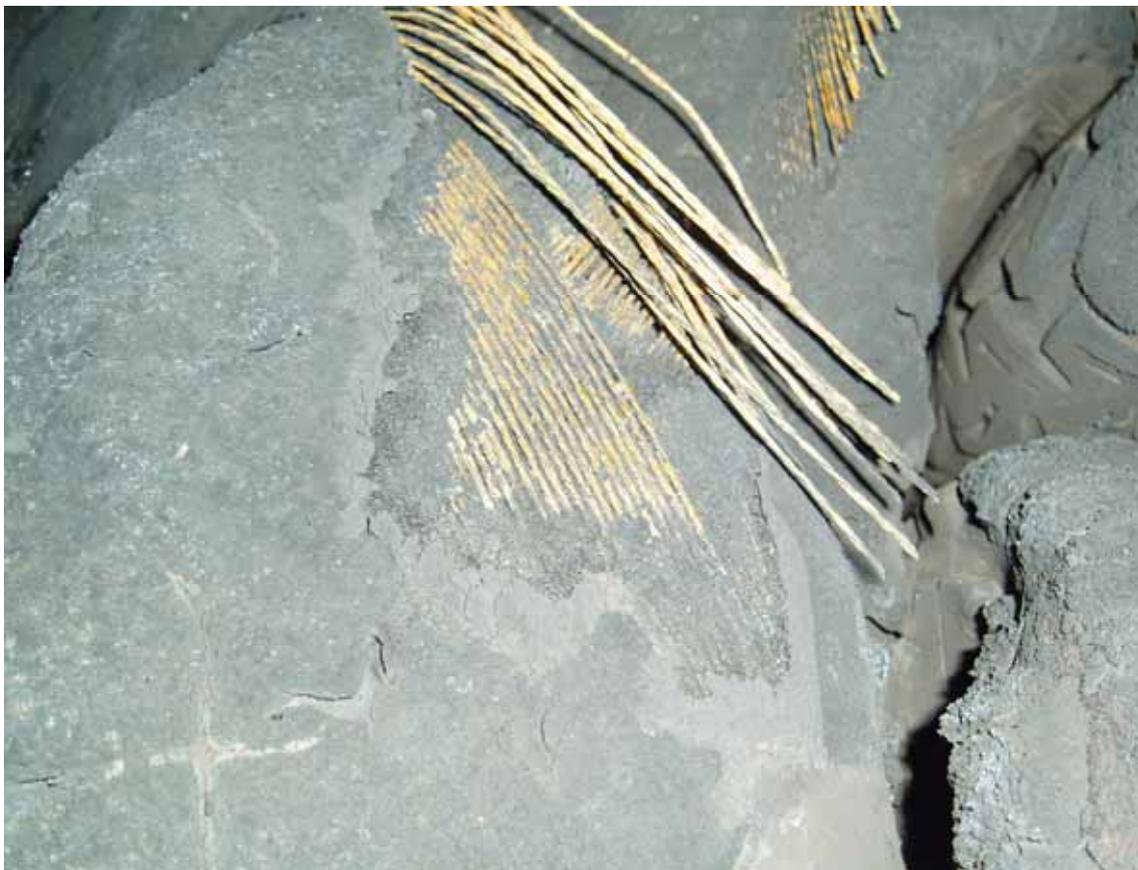
Figure 6.1 Damaged tyre with exposed radial and reinforcing wires

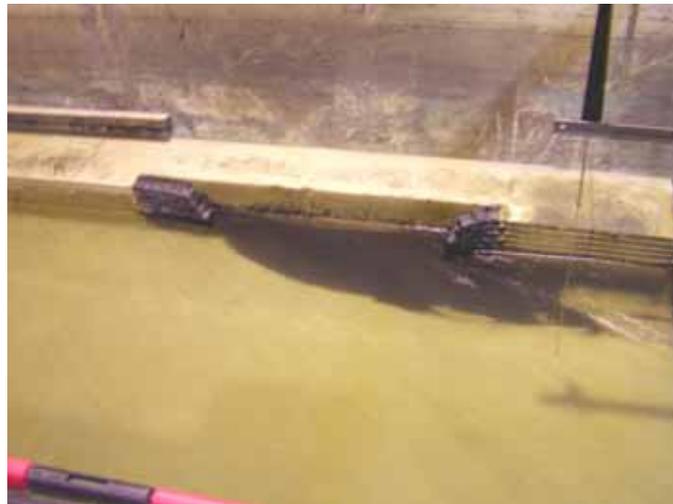
Figure A6.4 Collapse of bank – nominal water depth 0.1m

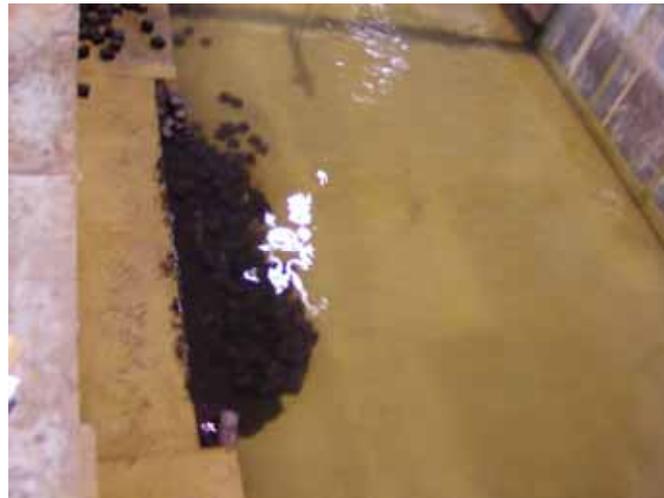
Figure A6.5 Failure of the bank (nominal depth 0.2m)

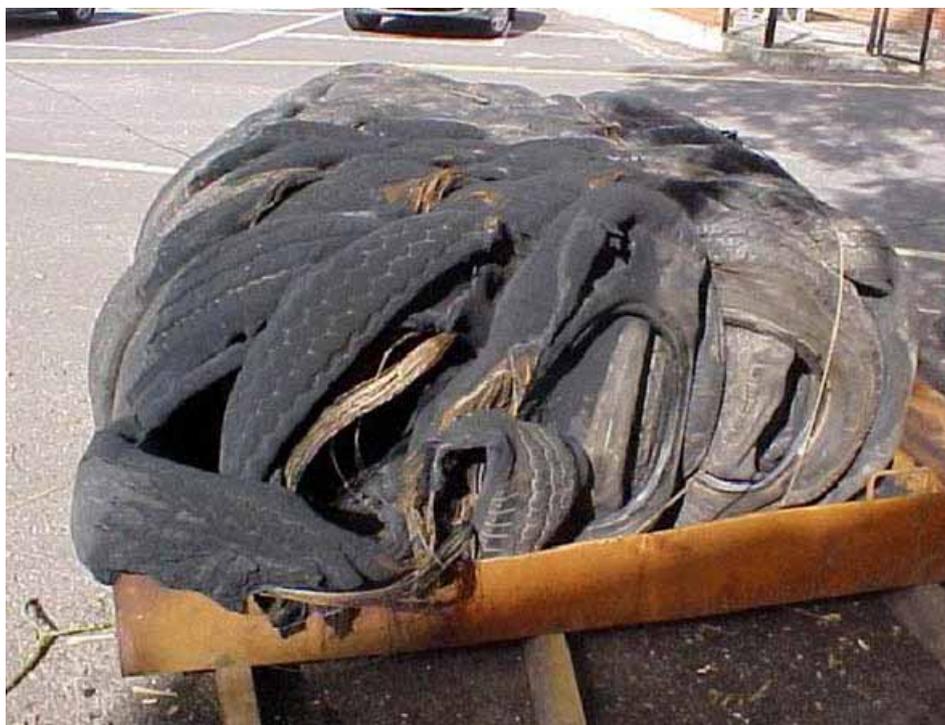
Figure A7.6 Fire damage sustained by the bale

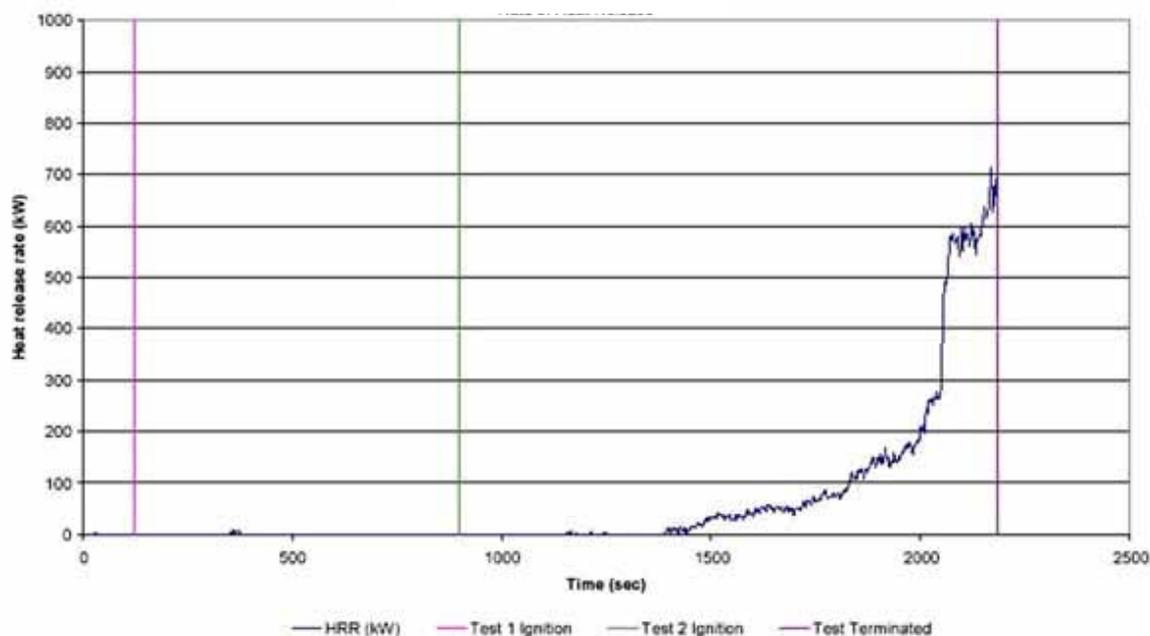
Figure A7.7 Tyre bale test 2: Rate of heat release

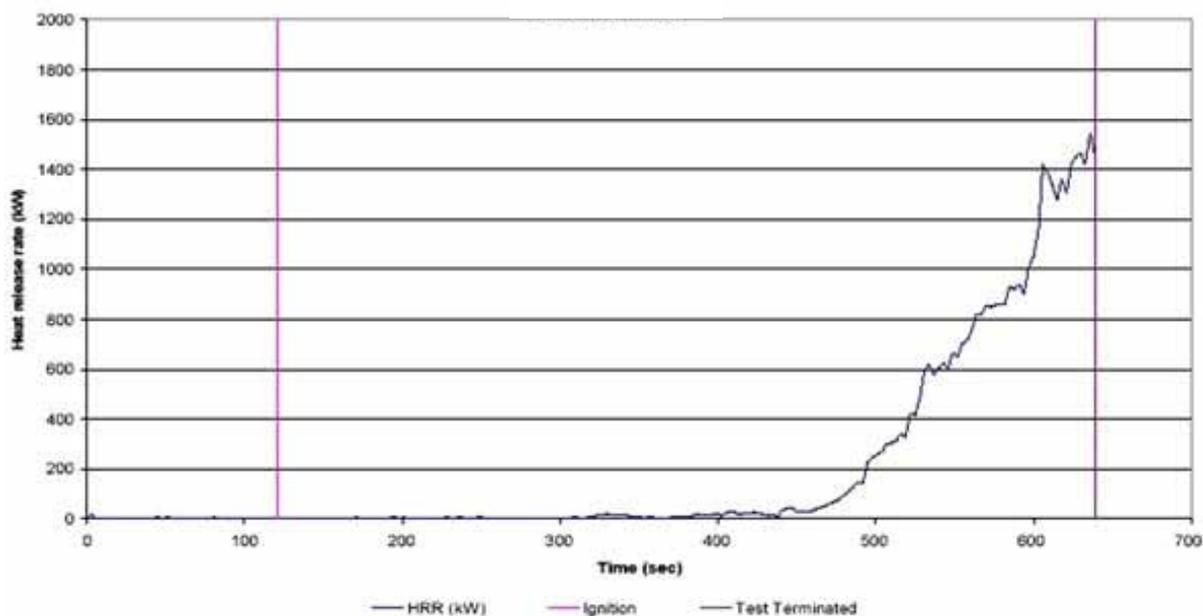
Figure A7.12 Tyre crumb: Rate of heat release

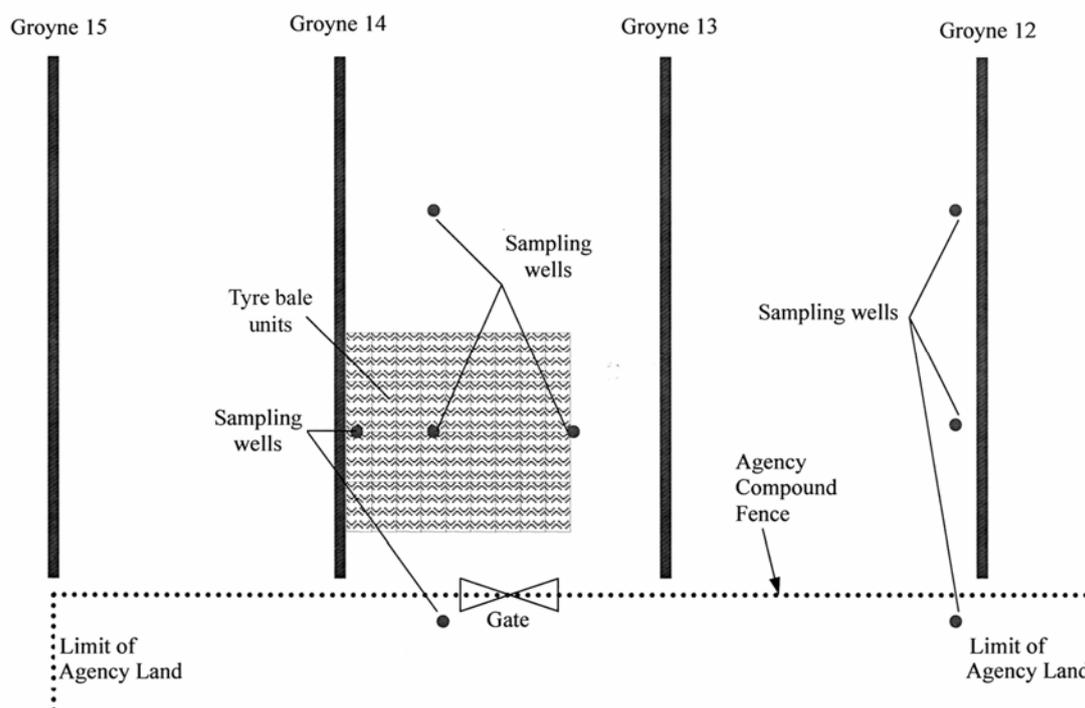
Figure A8.14 Positions of sampling wells at Pevensey

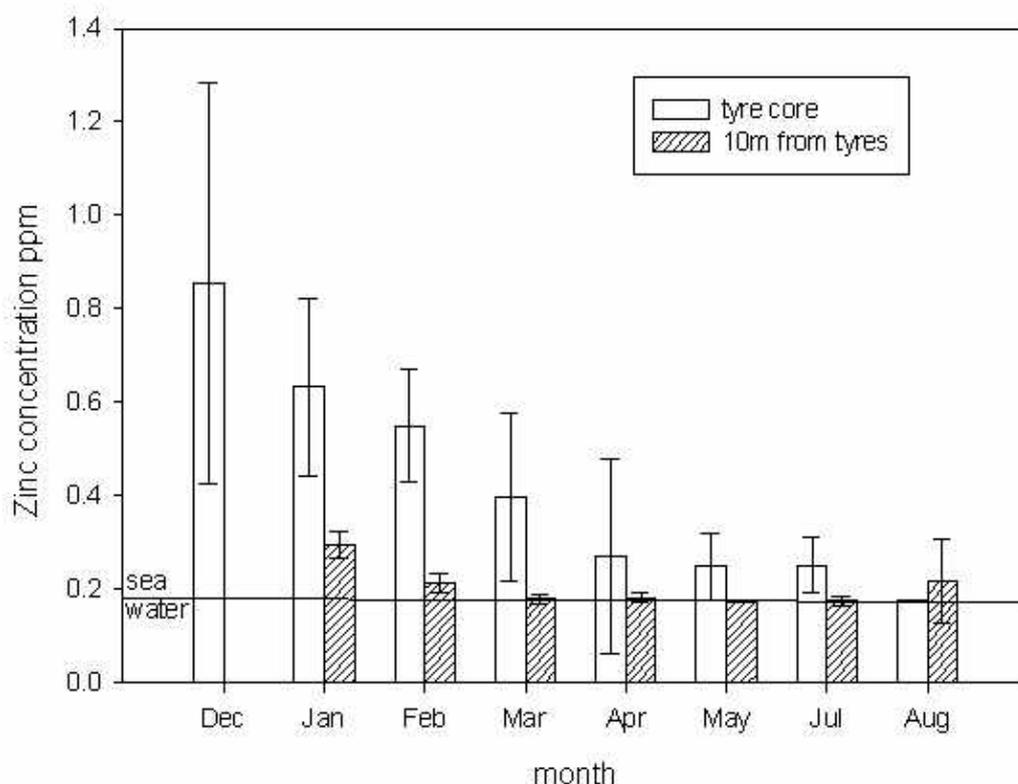
Figure A8.15 Average (+/- one standard deviation) zinc concentrations, (corrected for salinity) in tyre core wells and wells 10m seaward and landward of the tyre block (Dec 2002 – Aug 2003).

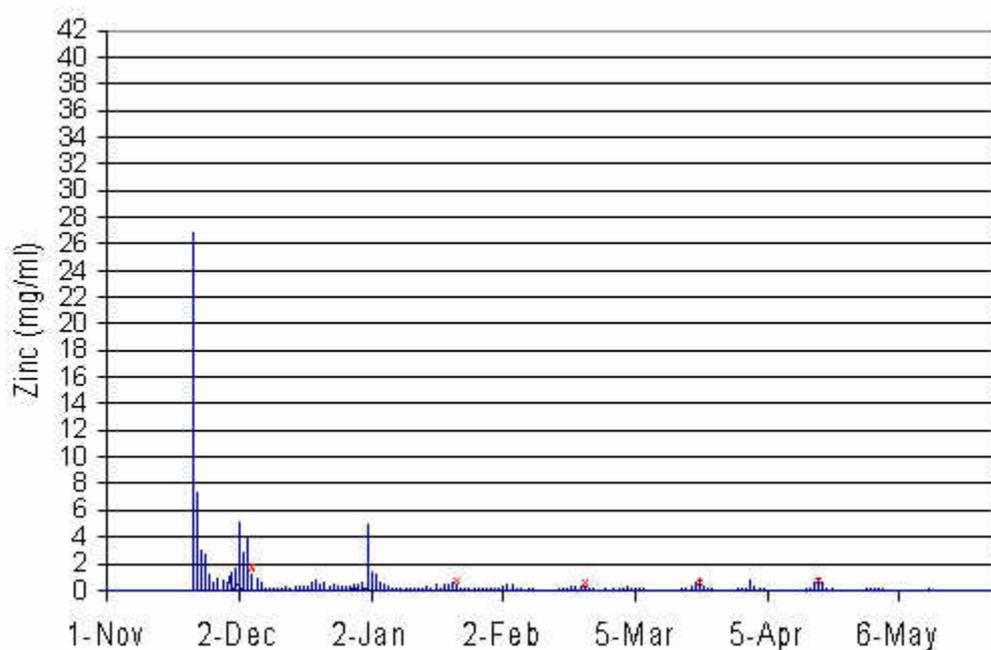
Figure A8.16 Modelled peak zinc concentrations within the tyre bales showing monthly spring tide peaks and decline with time.

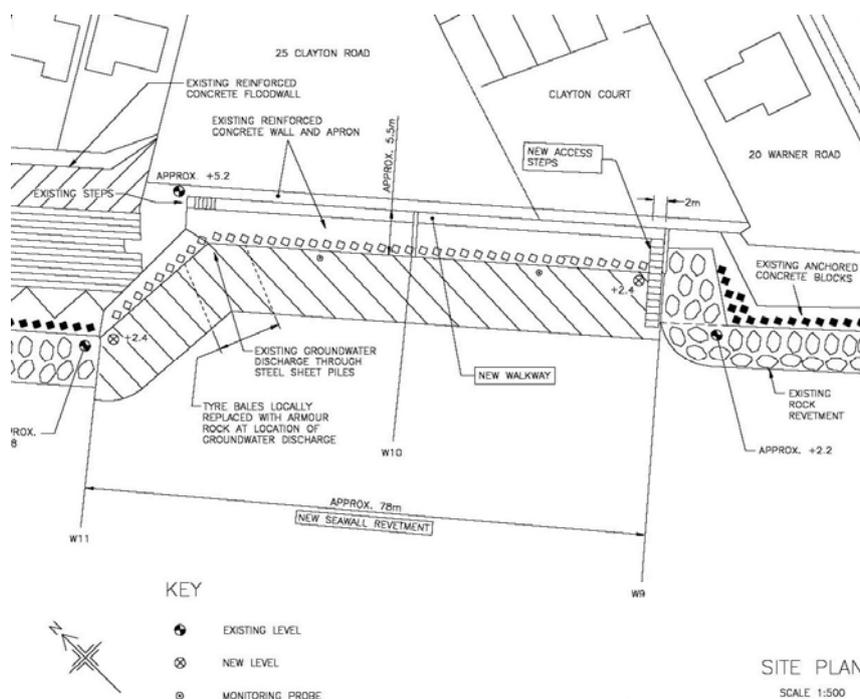
Figure A8.17b Selsey pilot site drawing
